## No Notch / No Toe Steering System Early Shaft Replacement

After early production of our No Notch/ No Toe steering systems prior to May 2011 we found better ways of machining and heat treating the 4 shafts included in the kit. These later style shafts are available for all of those who purchased these kits early on, which is the first 102 customers. 3 shafts are offered free of charge: 2 tie rod shafts and the steering arm shaft. For an additional amount you can get the matching idler arm shaft as well, although it is not critical from a functional standpoint. All shafts ship for free.

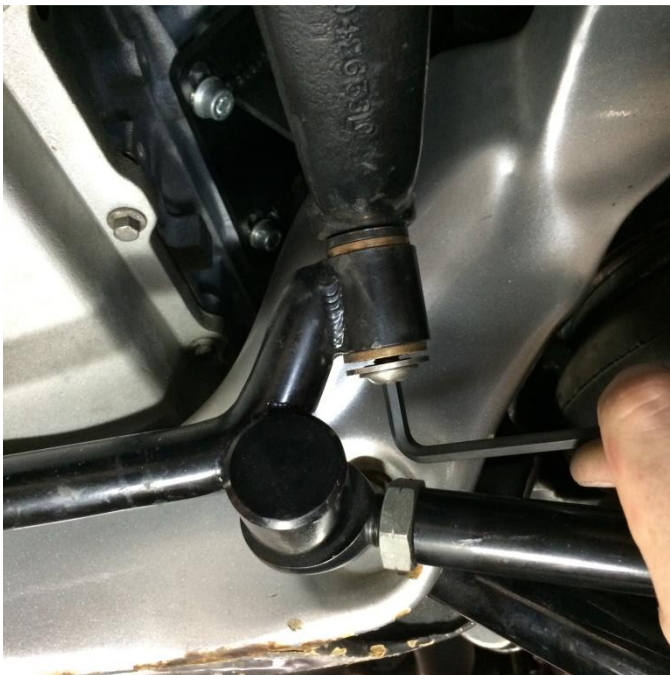
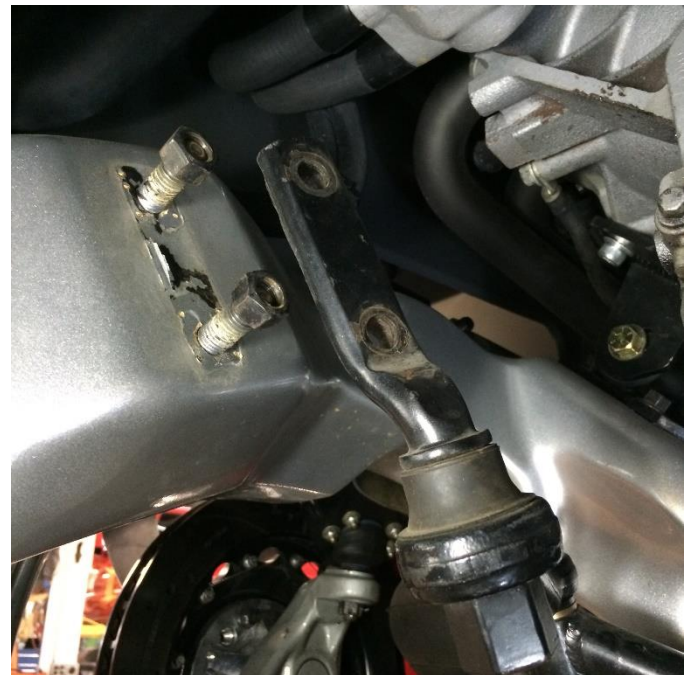
1 & 2

Loosen the allen bolt retaining the steering arm bushing. If both bushings are being replaced, then loosen the allen on the idler arm side also. If the idler arm shaft is staying in place, then unbolt the idler from the frame to allow the centerlink to drop down.

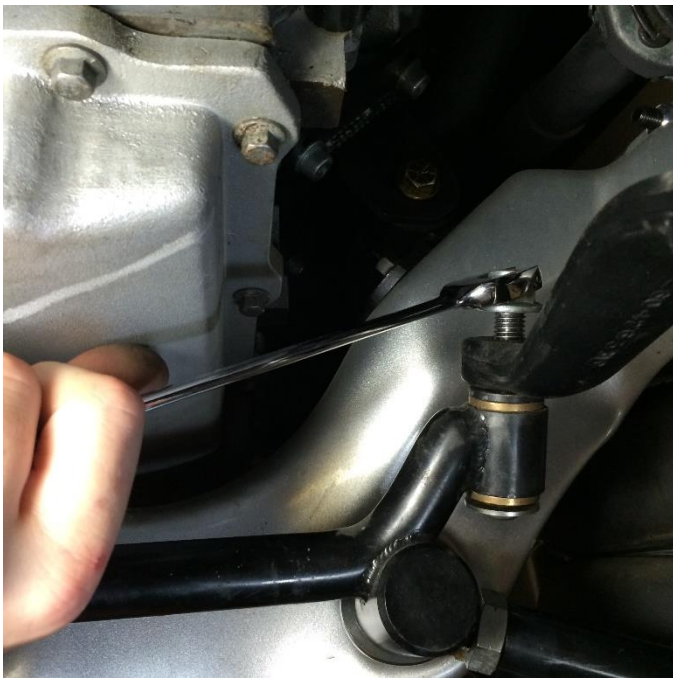
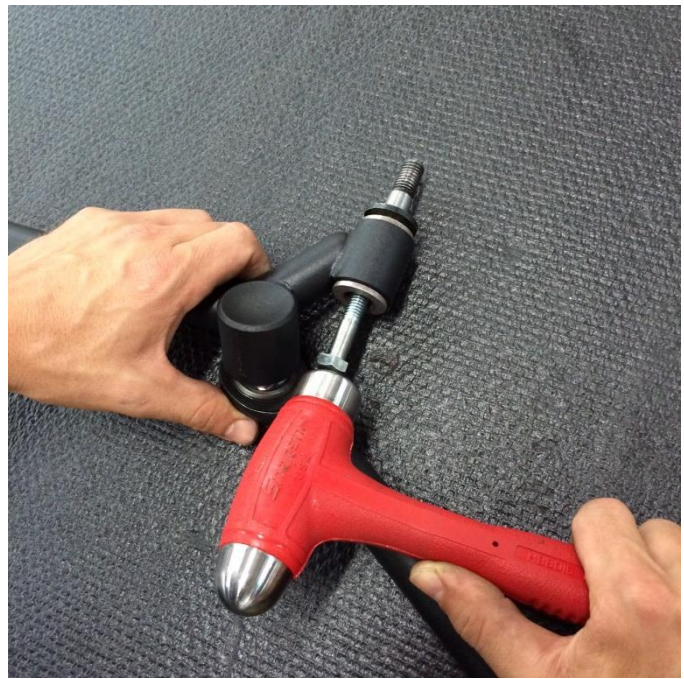
### 3 & 4

Loosen the nut on top of the steering arm (and also the idler if it is being replaced). The nut should be ran up until it is flush with the end of the shaft, then it can be tapped out with a brass hammer. Remove the outer tie rods from the spindles to allow the steering kit to be removed completely. Once the system is free from the vehicle, a 2 inch long 3/8 – 16 bolt can be threaded into the bottom of the shaft in order to hammer it out of the bushing.

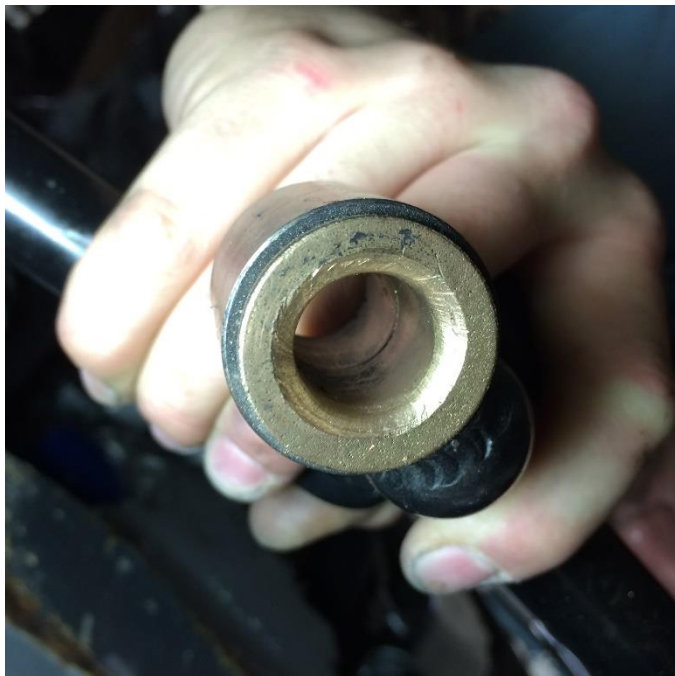
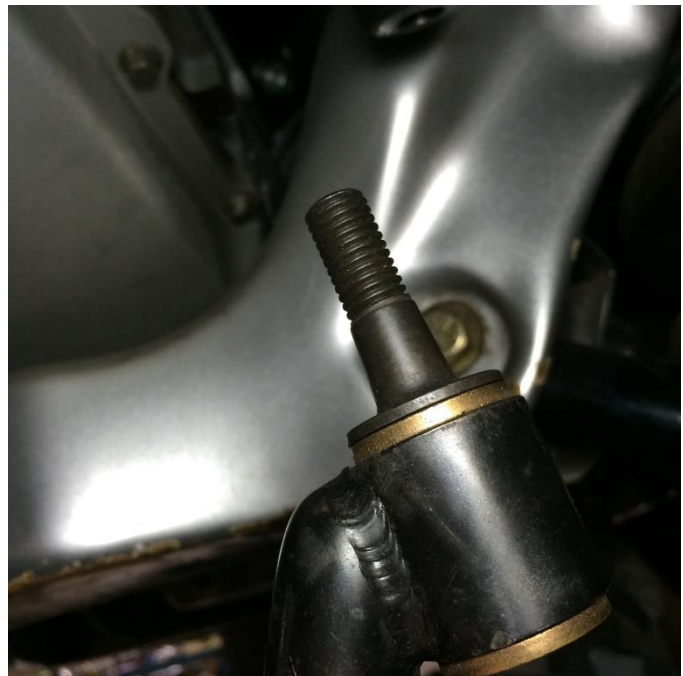
### 5 & 6

The bronze bushing will need to be chamfered so that the new shaft fits all the way down into it, and no space can be seen between the flange of the new shaft and the bushing. After this is done, remove the bushing and slide 1 of the supplied teflon washers onto the shaft. (If your parts didn't come with teflon washers, proceed to the next step).

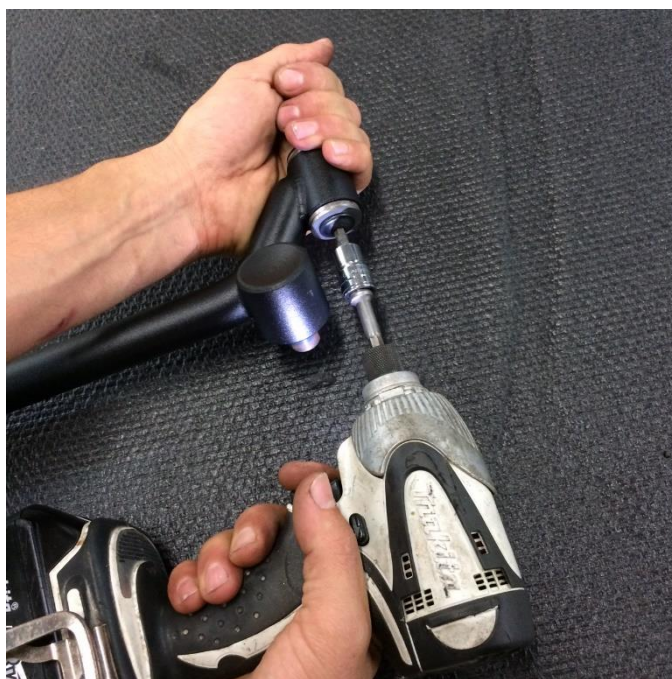
7

It's very important that this step be followed exactly. Each shaft must be fit with each bushing. With 1 teflon washer in place, insert the new bolt and the existing stainless washer and tighten the assembly. The shaft should be able to spin when the allen bolt locks down on it. **It's imperative that the bolt does not lock down against the bronze bushings.** If it does, the teflon washer can be removed and the bolt tightened back up again. If the bolt and washer still lock down on the bronze bushings before tightening against the end of the shaft, then it may be necessary to sand the bronze bushings with 80 grit sandpaper and a block, until the bolt and washer lock down on the shaft as intended. If the bolt locks down on the shaft but it is loose, then a second teflon washer can be added to the assembly.

This process may take a few tries but it's critical to the safe operation of the system. Repeat all the same steps on the idler side, if it is being replaced.

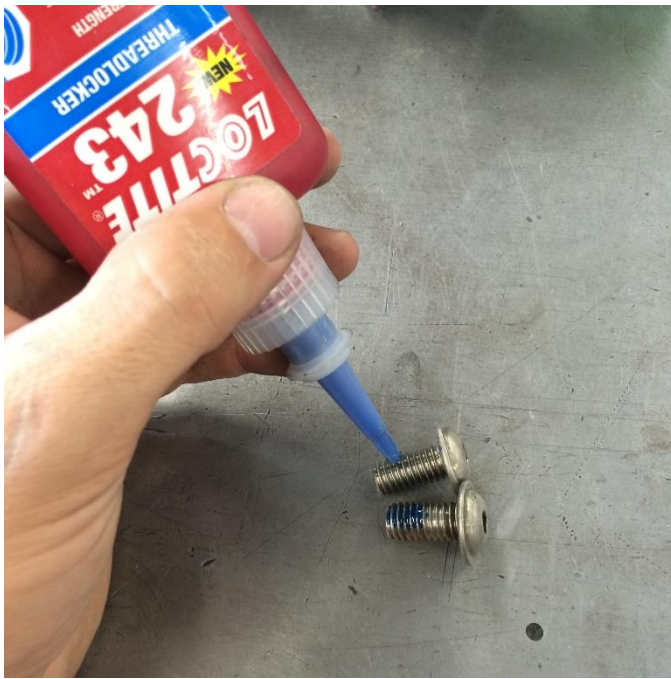
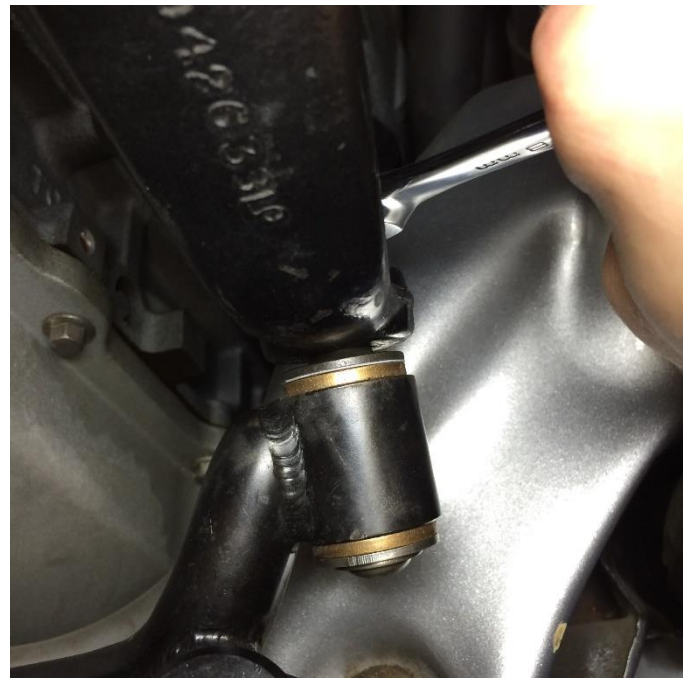
**8 & 9**

With the shafts properly fit, the new allen bolt must have medium strength threadlocker applied and tightened back into the bushings with the stainless washers in place. The centerlink can then be reinstated into the steering arm and the idler arm reattached.

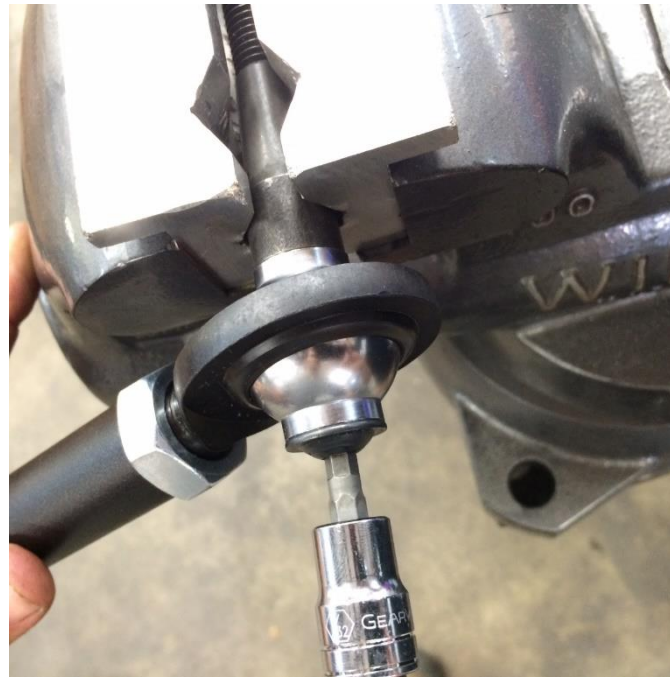
**10**

The outer tierod shafts simply need replaced with the new parts. It may be necessary to hold the original shafts in a vise in order to break loose the old allen bolts. Threadlocker **MUST BE USED** on the new bolts during reassembly.
